Contractor Report ARWEC-CR-00001

CRYOFRACTURE DEMILITARIZATION OF MUNITIONS (PHASE II)

John F. Follin
General Atomics
P.O. box 85608
San Diego, CA 92186-9784

March 2000

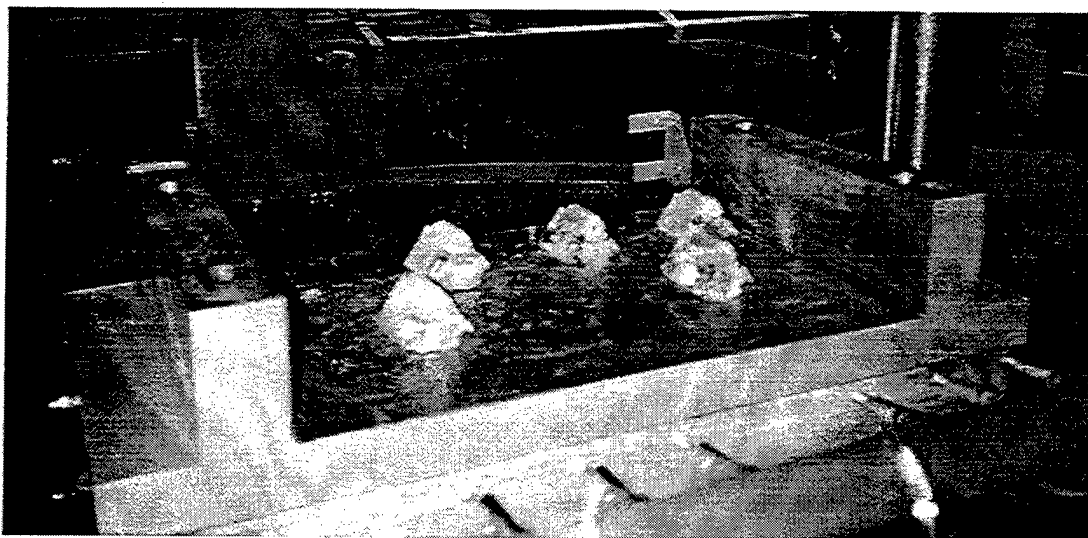
Figure 30
Transport fixture in cryofracture press

Figure 29 is a picture of the Prab robot inserting a munition transport fixture with six ADAM mines into the cryobath. Figure 30 is a picture with a munition transport fixture depositing six cryo-cooled ADAM mines accurately onto the ADAM mine cryofracture press tooling. After the munitions were deposited on the tooling (fig. 31), the Prab robot removed the fixture from the press and returned the fixture to the staging area.

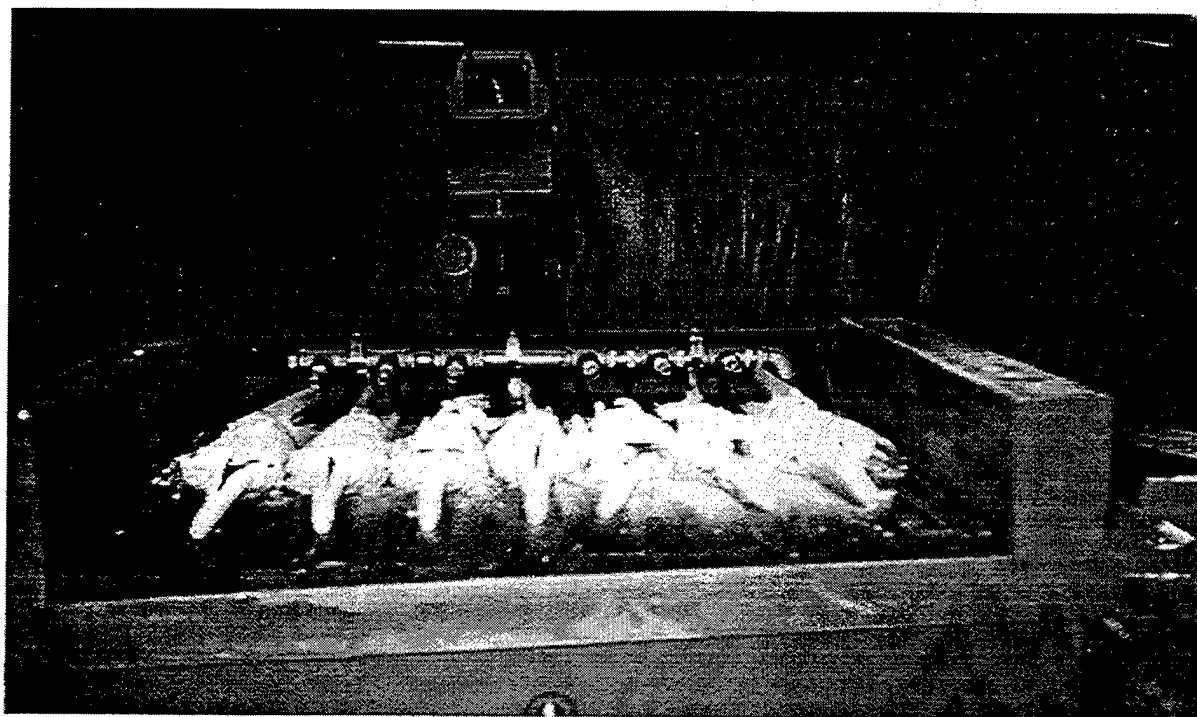
Figure 48
Cryofracture of live Rockeye II bomblets

Figure 46 shows the Prab robot inserting a munition transport fixture loaded with seven bomblets into the bath. The munitions were retrieved from the cryobath and deposited on the press tooling (fig. 47). Figure 48 shows the results of the flat plate crush of the Rockeye II bomblet. The bomblet body and explosive material have been accessed and are seen in many small pieces. Figure 49 shows the debris in the shuttle box after tooling tilt-table operation. Figure 50 shows the debris in the open grate furnace after shuttle box dumping. Good explosive accessing of the 247 Rockeye II bomblets was accomplished in all 37 tests.

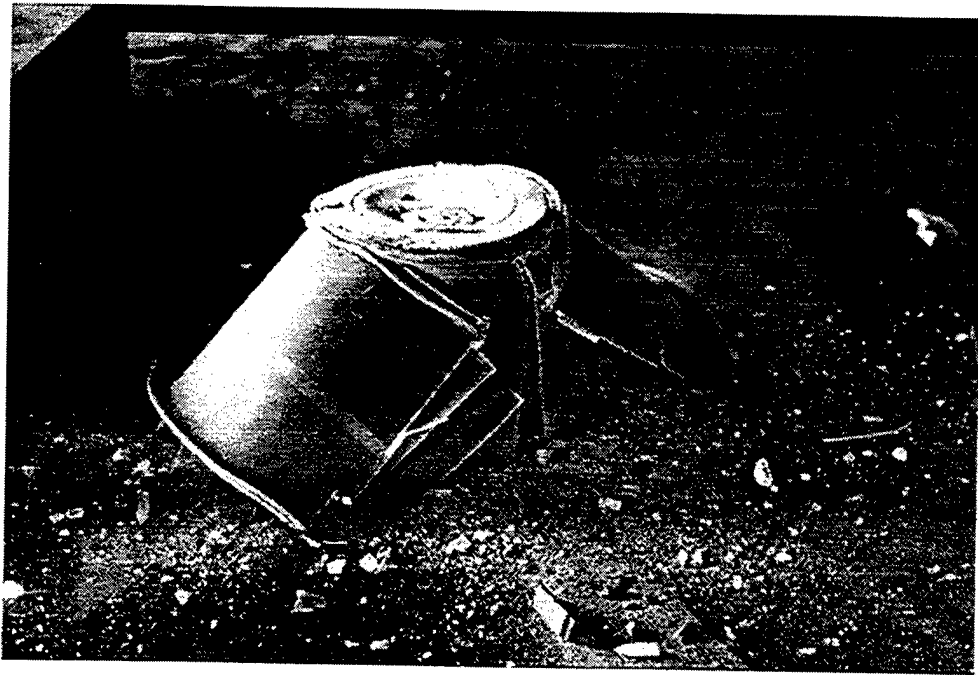
Figure 52
Cryofracture of inert M16A1 mine

Test 4 was the cryofracture of a vertically oriented mine using a 3.25-in. press closure spacing. This closure spacing produced a 2.04-in. crush of the mine following contact with the fuze cavity plug in the top of the mine. Figure 51 shows the mine on the press tooling just prior to the fracture. Figure 52 shows the mine debris on the press tooling following the cryofracture. For this test, the debris was swept off the press tooling and allowed to fall into the fragment cart in order to provide an assessment of the dispersion produced by impact with the press discharge chute and the fragment cart. Figure 53 shows the mine debris in the fragment cart. Excellent breakup of the mine canister and internals, including the booster cavity was achieved.

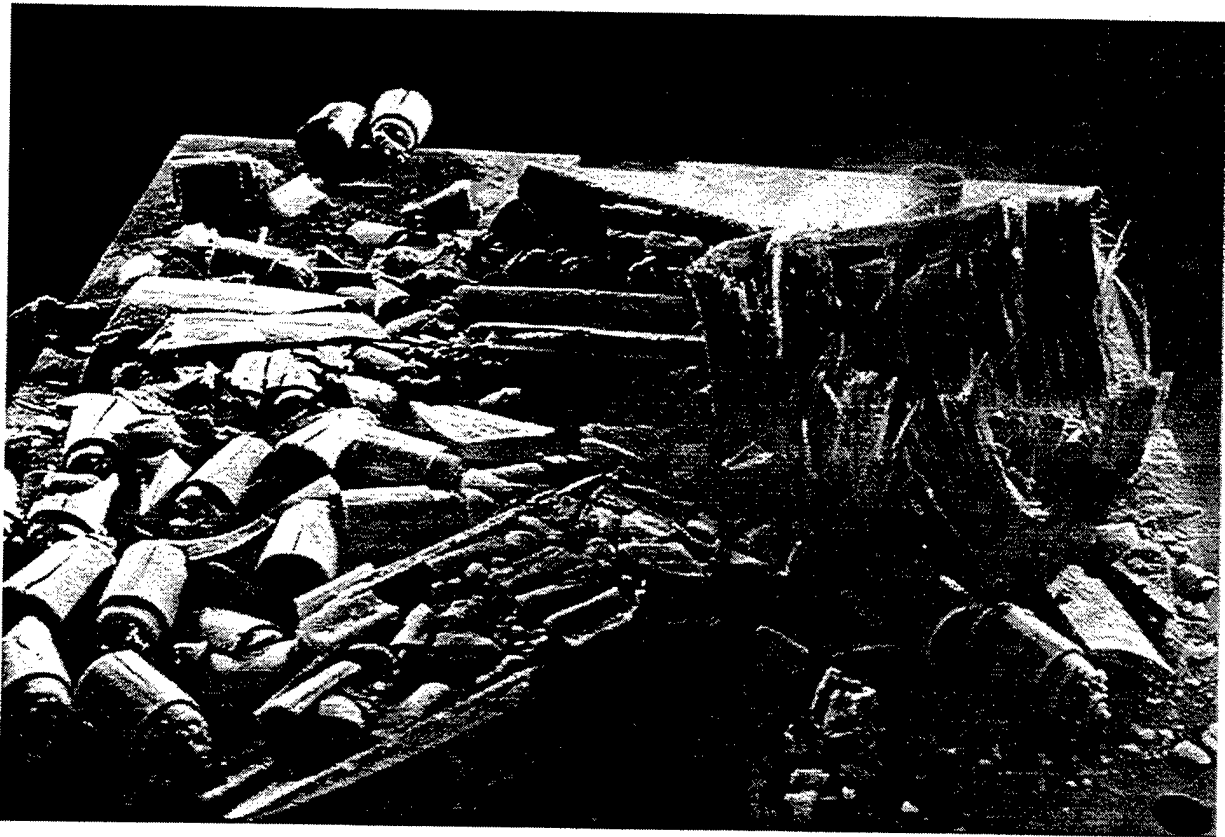
Figure 66
M483A1 projectile debris after cryofracture

Test 11 cryofractured a full-up M483A1 projectile containing 88 submunition grenades. The projectile was positioned on the tooling so that the butt end hung off the end of the lower flat plate. Figure 65 shows the projectile on the press tooling just prior to the fracture. The press closure spacing crush specimens are also shown in figure 65. Figure 66 shows the projectile debris on the tooling following the fracture. The butt end was sheared off the projectile body during the fracture. The nose end of the projectile was broken off and ejected from the tooling during the fracture. The expulsion charge cavity was not accessed. Four press strokes were used in order to obtain maximum crushing. Excellent breakup of the projectile body was obtained. Fourteen unaccessed submunition grenades were ejected from the tooling during the first press stroke. Nine of the 74 grenades that remained on the tooling were not adequately accessed during the four press strokes. On the fourth press stroke the press closed to a spacing between the flat plates of 1.40 in., a 4.70-in. crush after contact with the projectile body. Note that the amount of crushing obtained in this test was greater than in test 10. This is the opposite of what would be expected due to the size of the two test specimens and is an indication of the wide variation in results that can be expected.
